**A REPORT ON THE LEVEL 1
INSPECTION AND TESTING AT
1100 POUND ROAD
WATERSIDE ESTATE
CLYDE NORTH**

Report No: 1170051-51

CITY OF CASEY
WATERSIDE ESTATE
MW WETLAND BULK EARTHWORKS
FILLING PLAN

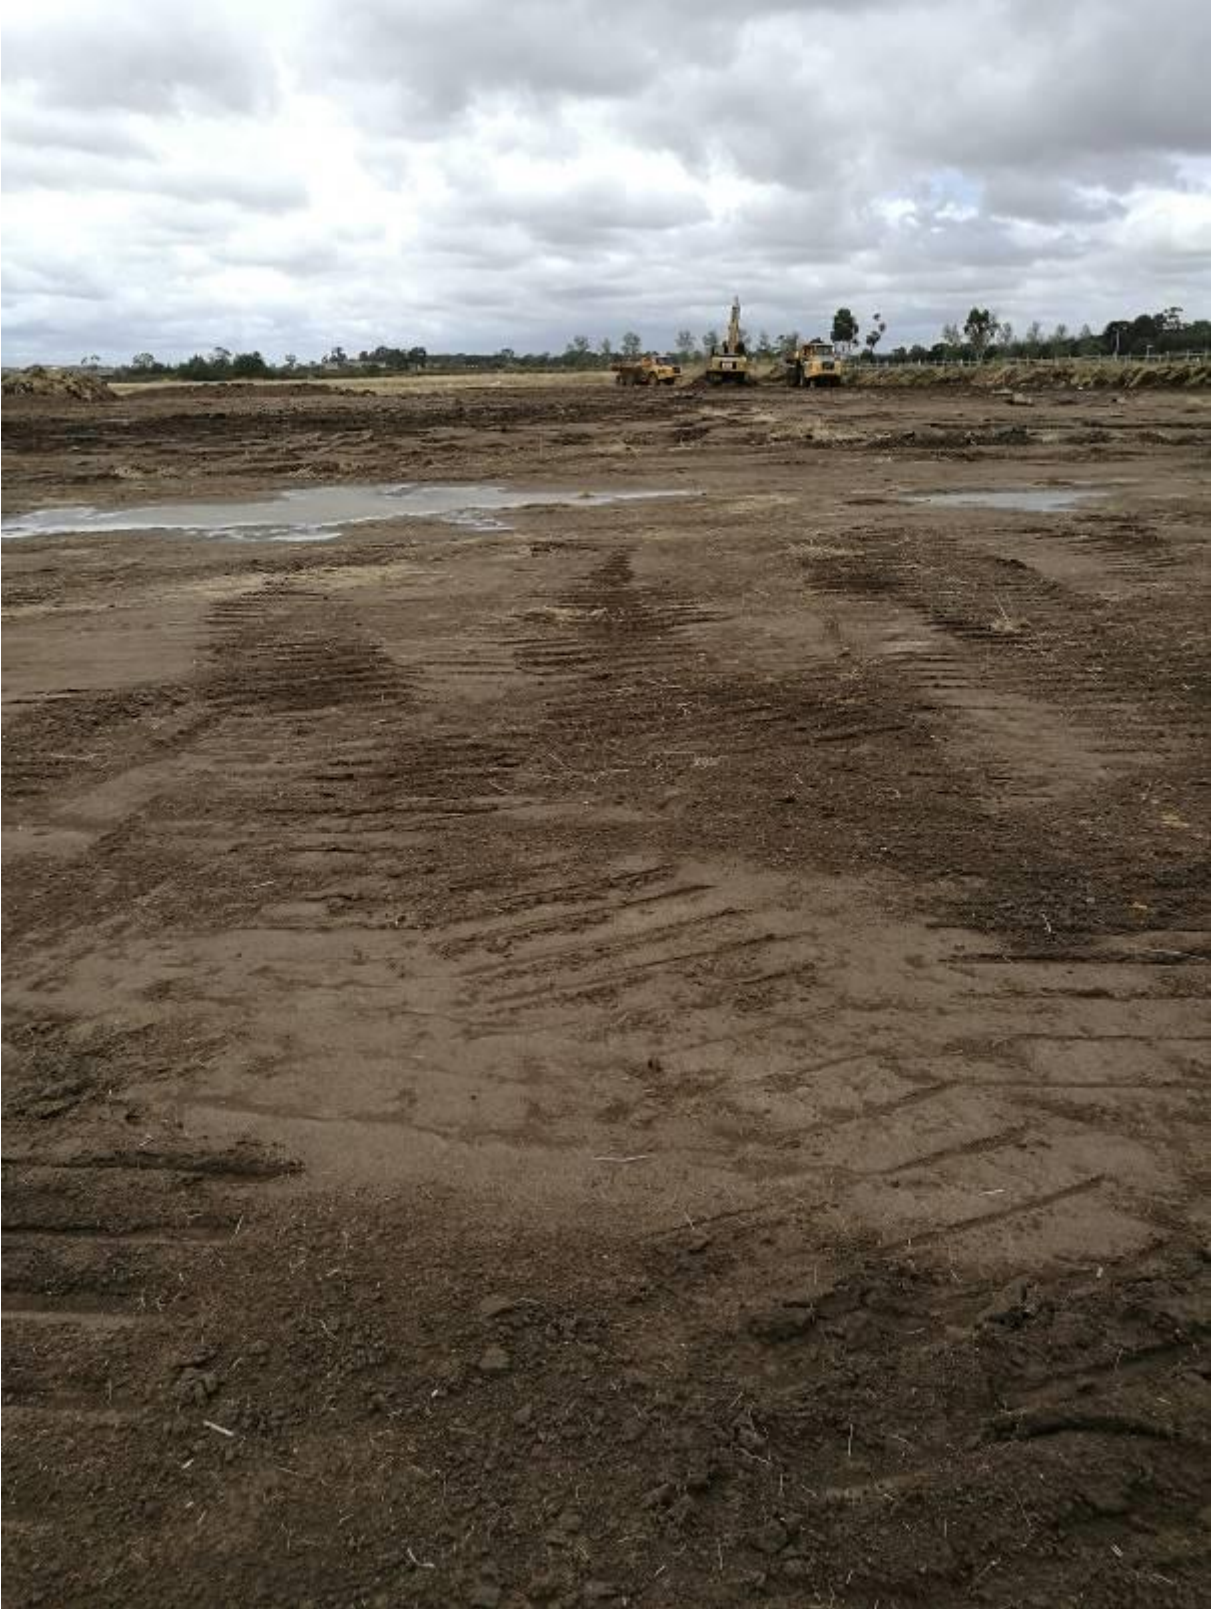
IMAGE FROM SITE
WATERSIDE ESTATE, CLYDE NORTH

A visual inspection of the area shown on the attached plan was undertaken on 20 January 2017. The area was stripped of all topsoil and organic matter to a firm subgrade. This was found to be adequate for filling to commence.

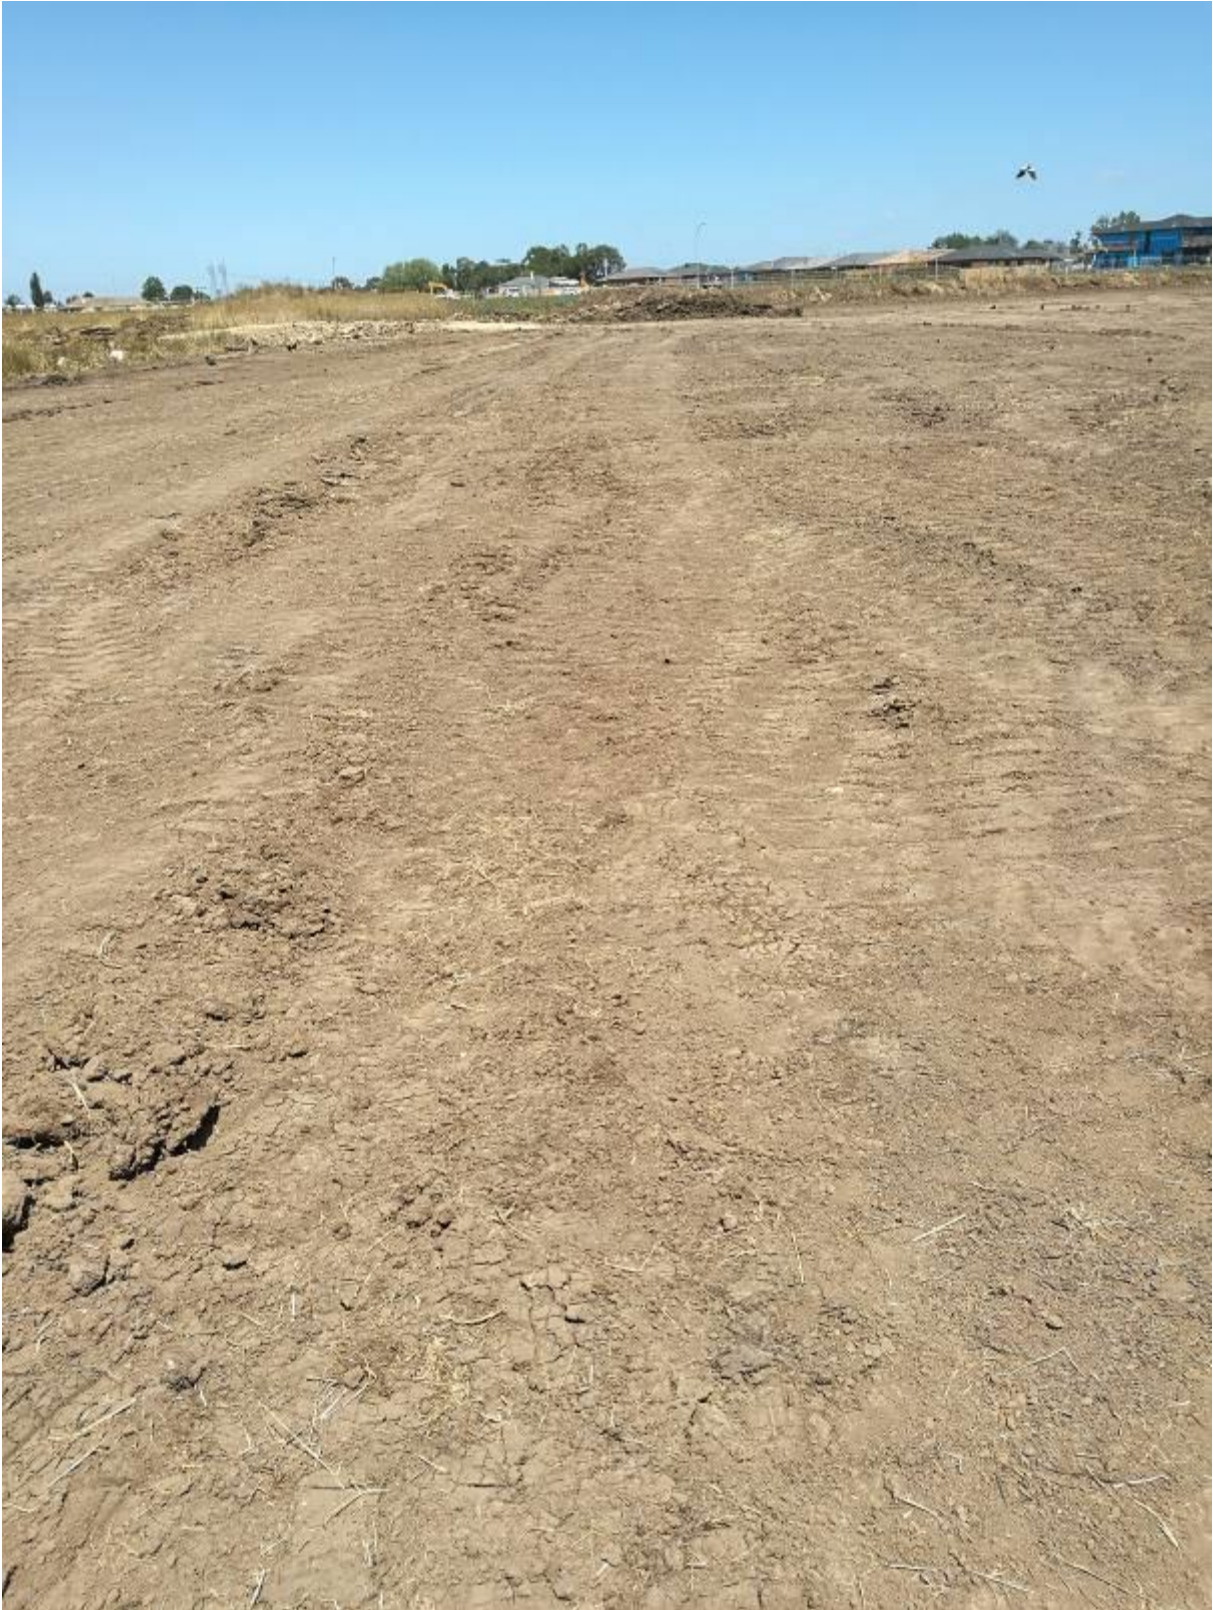
IMAGE FROM SITE
WATERSIDE ESTATE, CLYDE NORTH

A visual inspection of the area shown on the attached plan was undertaken on 25 January 2017. The area was stripped of all topsoil and organic matter to a firm subgrade. This was found to be adequate for filling to commence.

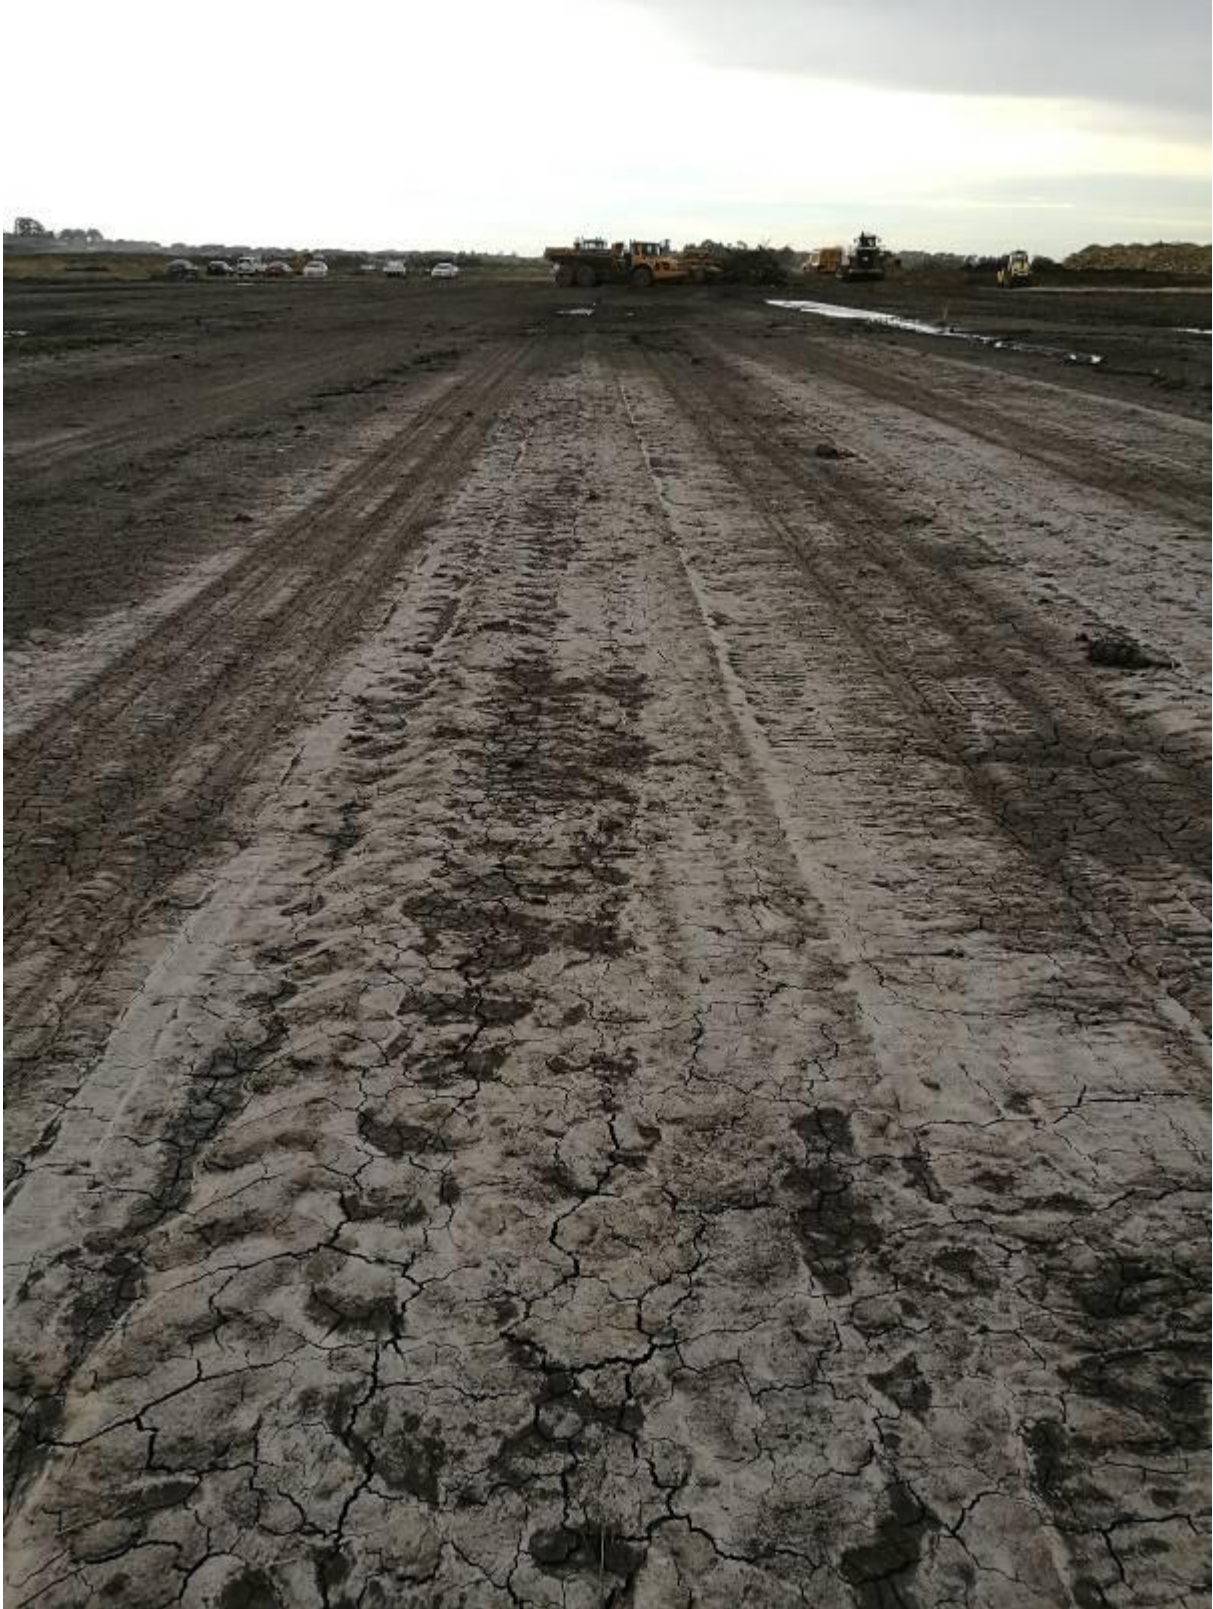
IMAGE FROM SITE
WATERSIDE ESTATE, CLYDE NORTH

A visual inspection of the area shown on the attached plan was undertaken on 30 January 2017. The area was stripped of all topsoil and organic matter to a firm subgrade. This was found to be adequate for filling to commence.

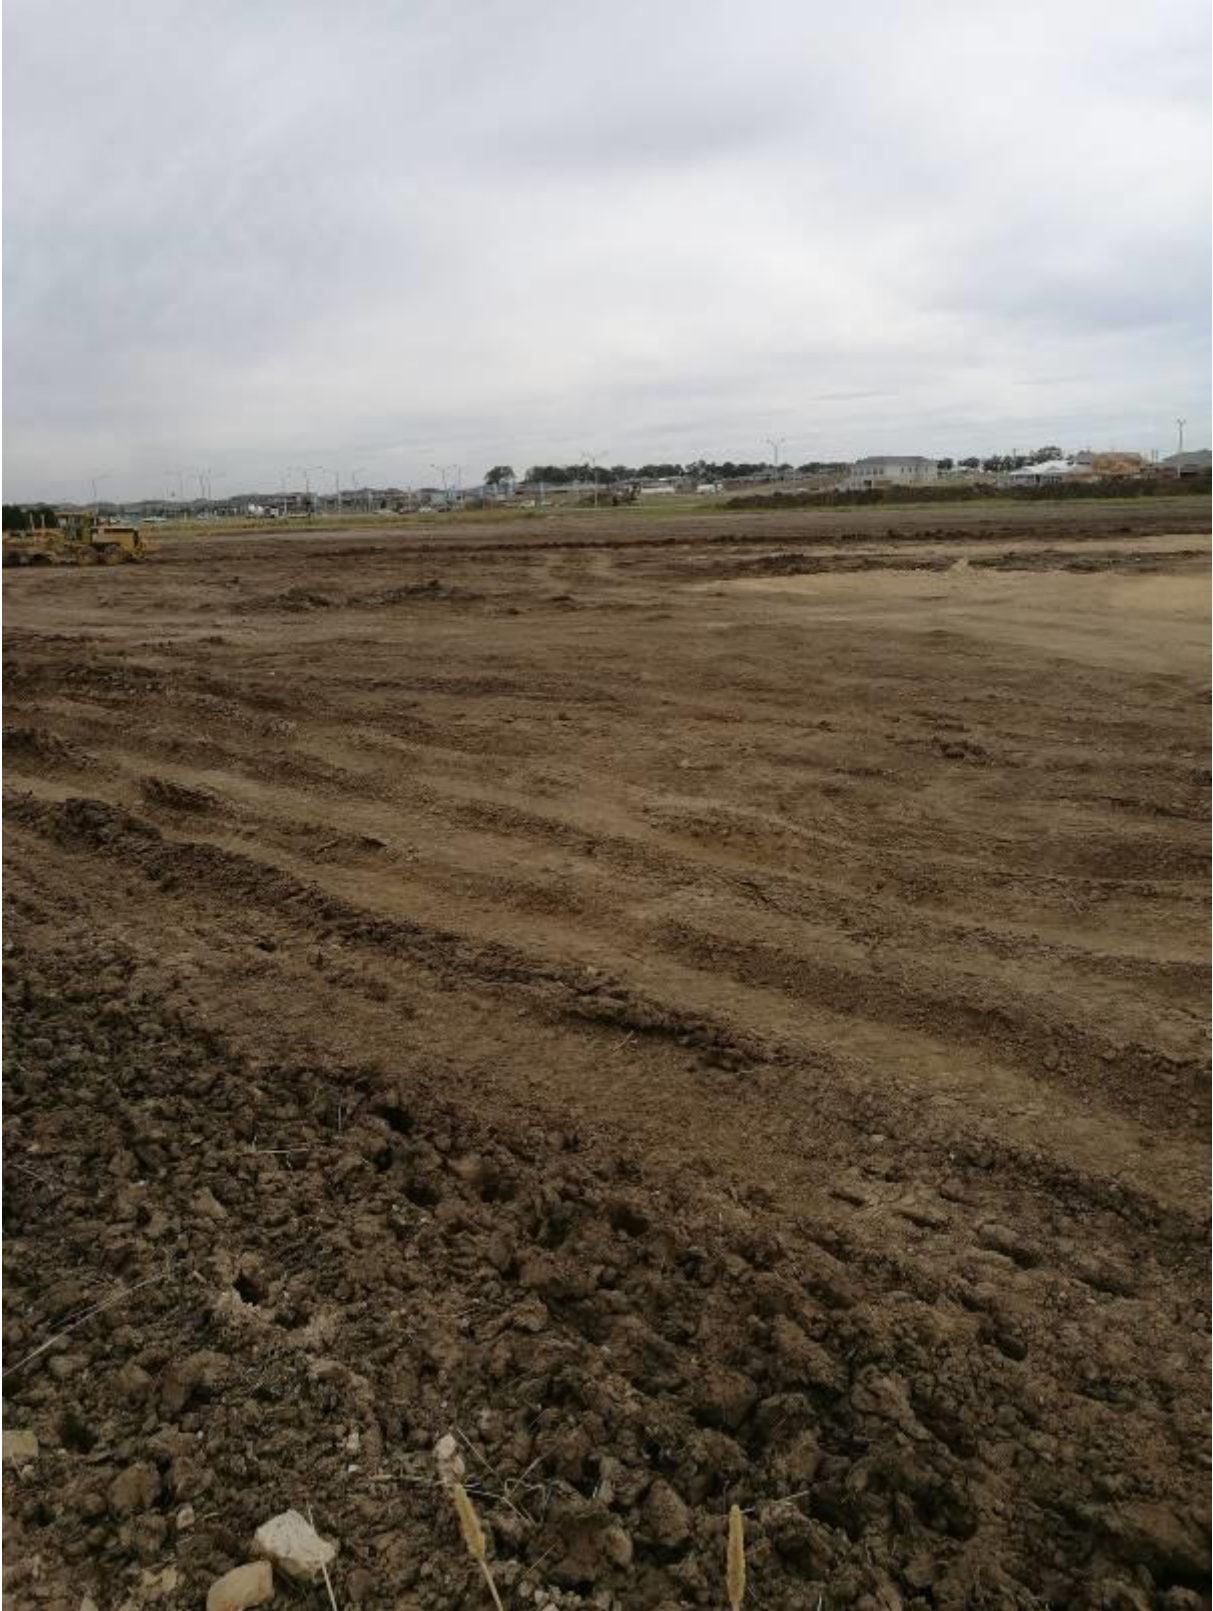
IMAGE FROM SITE
WATERSIDE ESTATE, CLYDE NORTH

A visual inspection of the area shown on the attached plan was undertaken on 1 February 2017. The area was stripped of all topsoil and organic matter to a firm subgrade. This was found to be adequate for filling to commence.

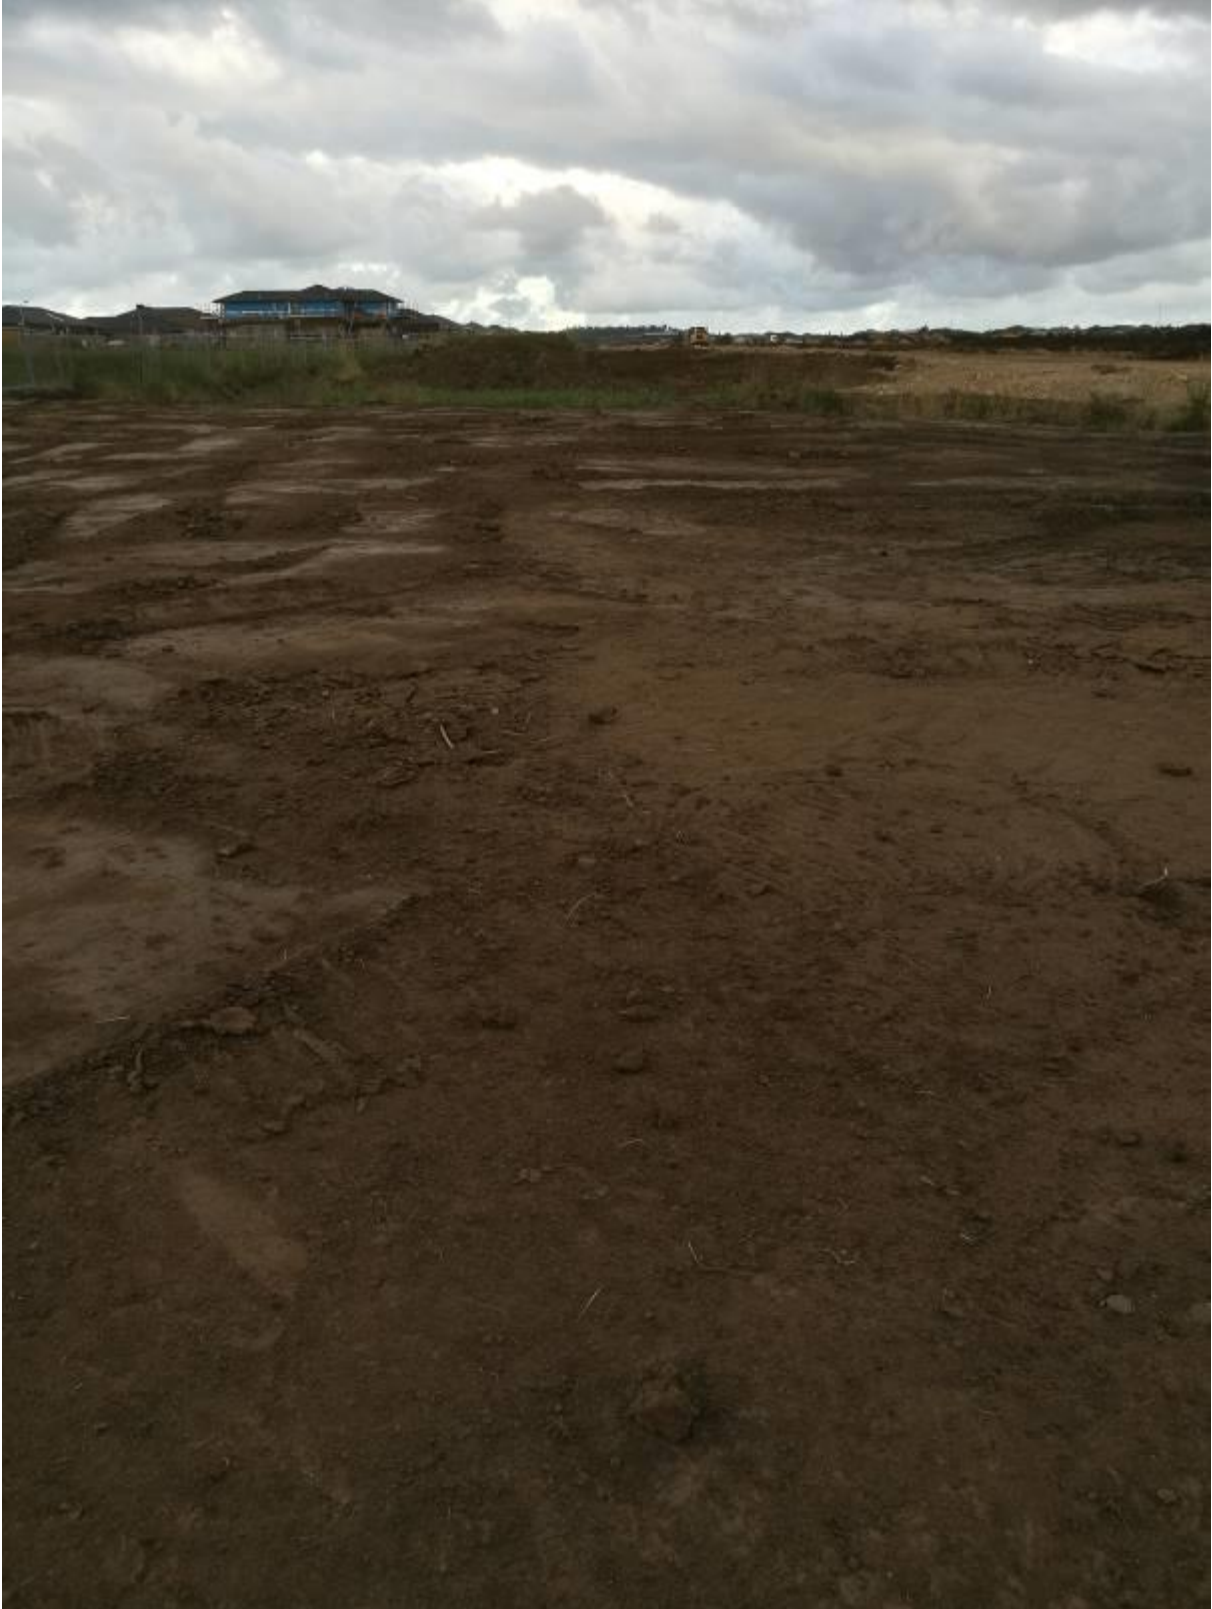
IMAGE FROM SITE
WATERSIDE ESTATE, CLYDE NORTH

A visual inspection of the area shown on the attached plan was undertaken on 18 February 2017. The area was stripped of all topsoil and organic matter to a firm subgrade. This was found to be adequate for filling to commence.

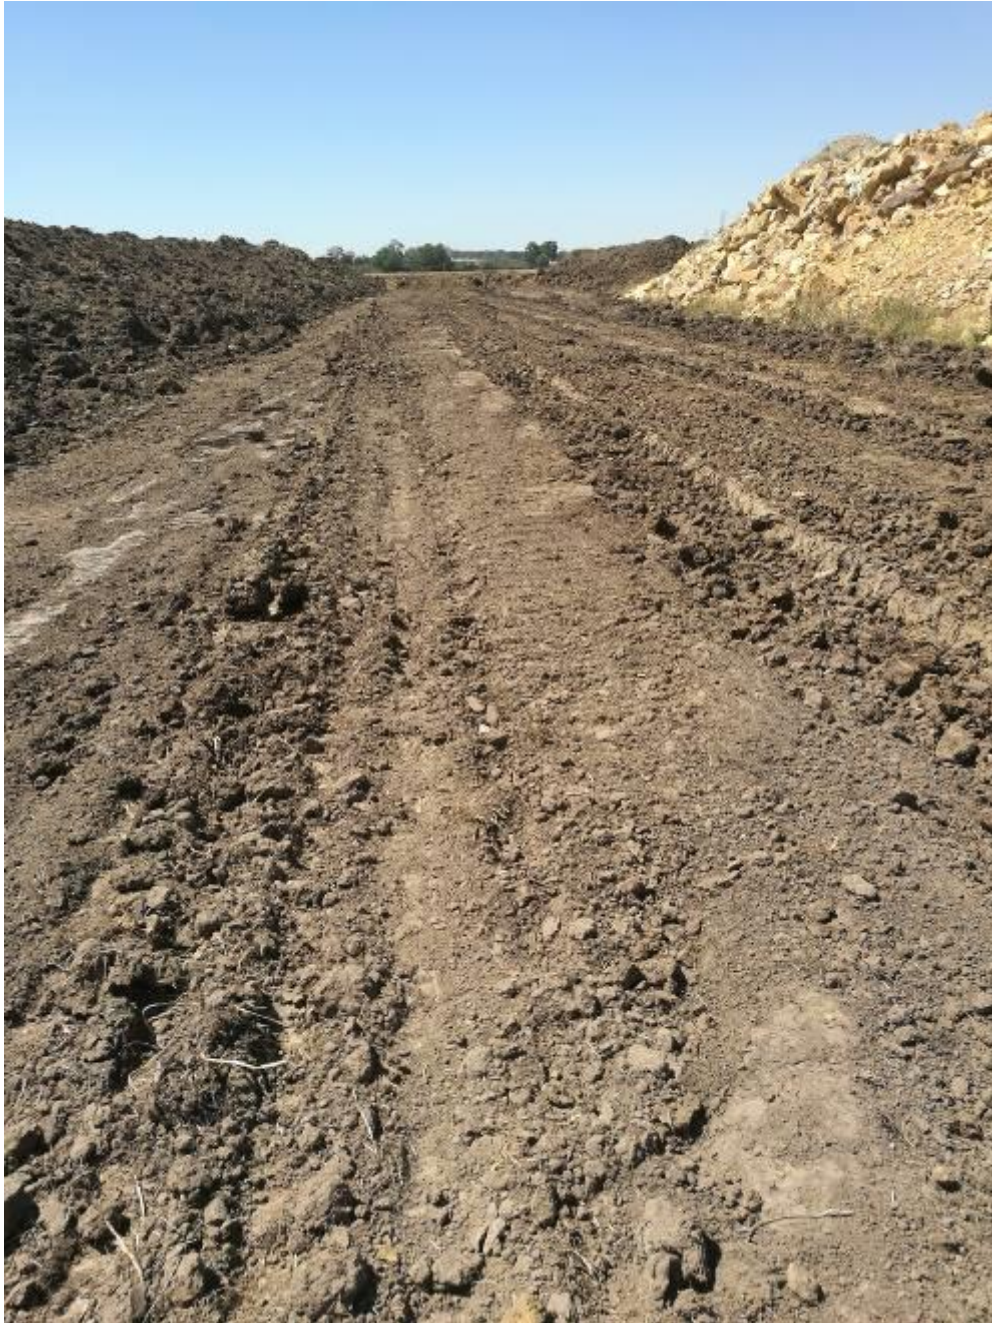
IMAGE FROM SITE
WATERSIDE ESTATE, CLYDE NORTH

A visual inspection of the area shown on the attached plan was undertaken on 1 March 2017. The area was stripped of all topsoil and organic matter to a firm subgrade. This was found to be adequate for filling to commence.

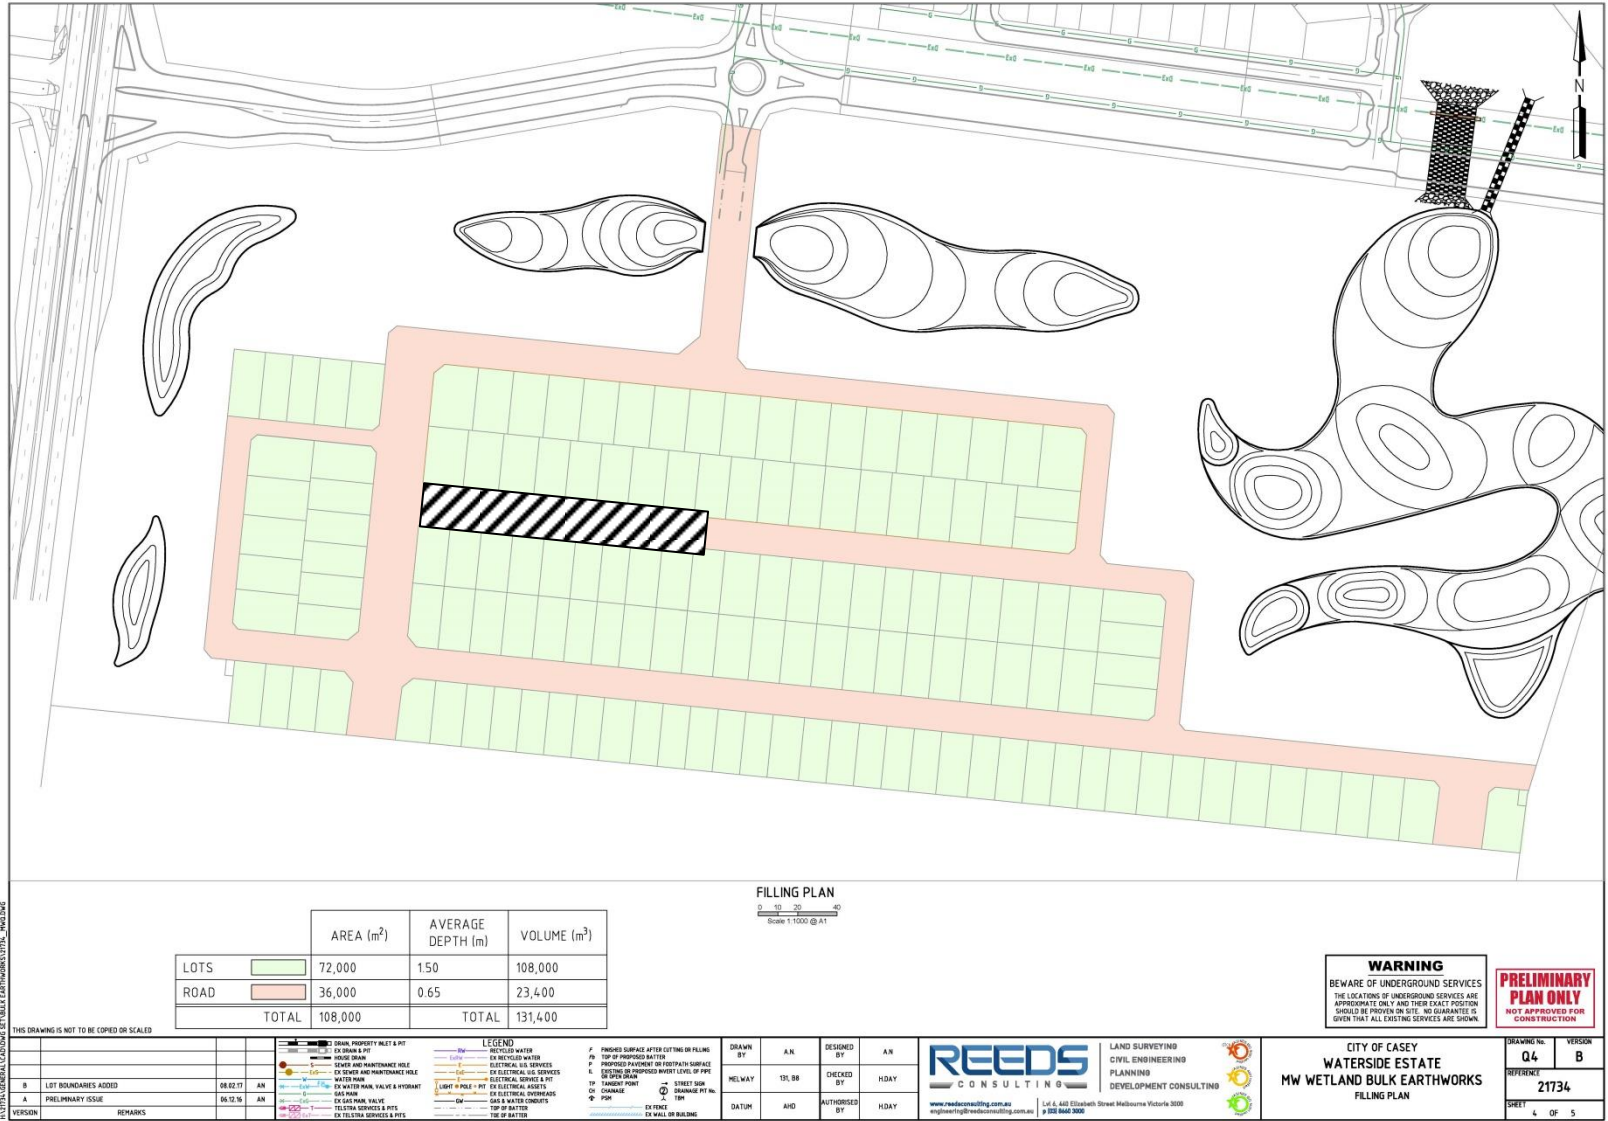
SITE INSPECTION PLAN: WATERSIDE ESTATE, CLYDE NORTH

A visual inspection of the area shown on the attached plan was undertaken on 3 March 2017. The area was stripped of all topsoil and organic matter to a firm subgrade. This was found to be adequate for filling to commence.

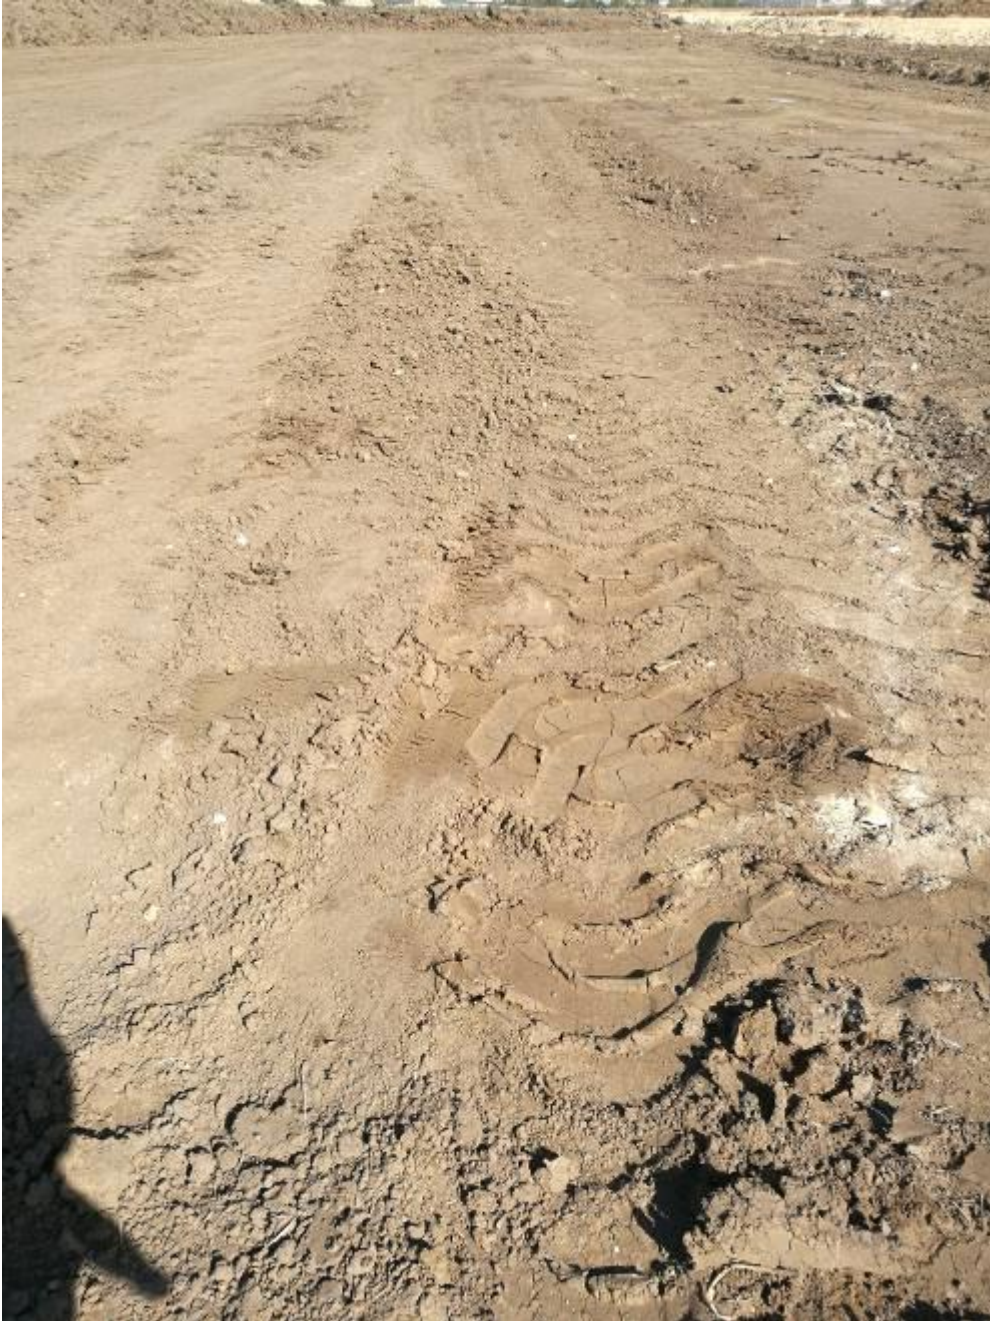
IMAGE FROM SITE

A visual inspection of the area shown on the attached plan was undertaken on 6 March 2017. The area was stripped of all topsoil and organic matter to a firm subgrade. This was found to be adequate for filling to commence.

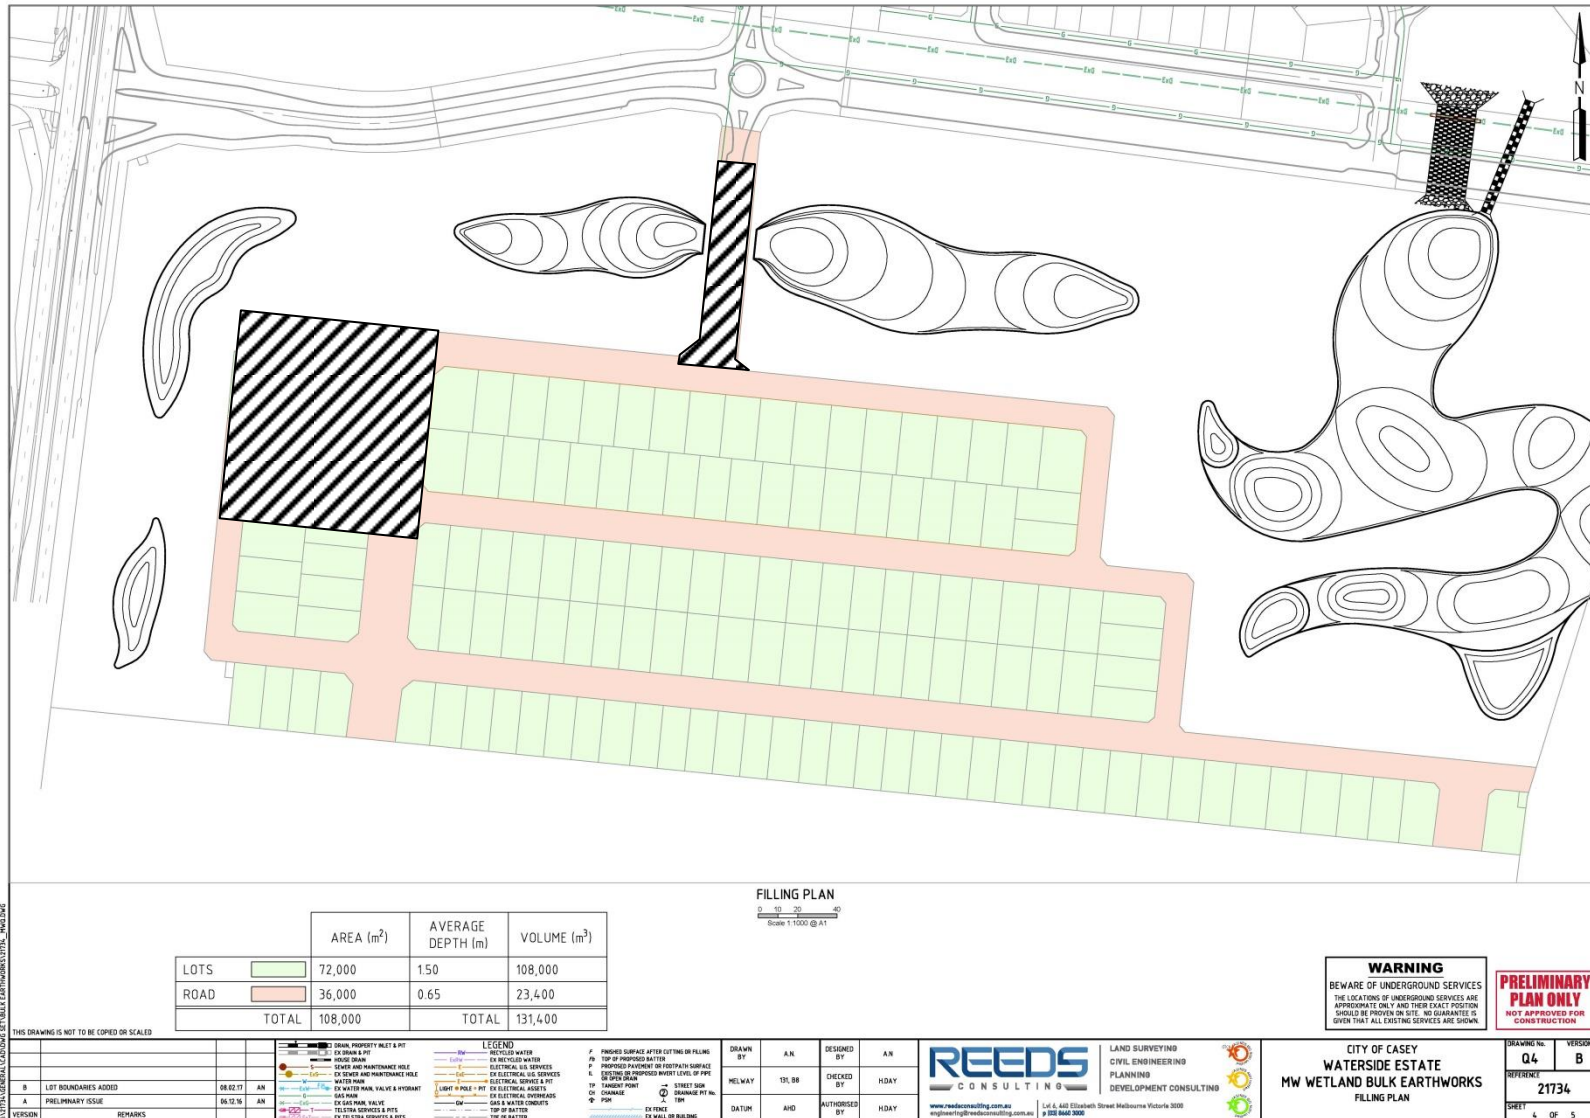
SITE INSPECTION PLAN: WATERSIDE ESTATE, CLYDE NORTH

A visual inspection of the area shown on the attached plan was undertaken on 7 February 2017. The area was stripped of all topsoil and organic matter to a firm subgrade. This was found to be adequate for filling to commence.

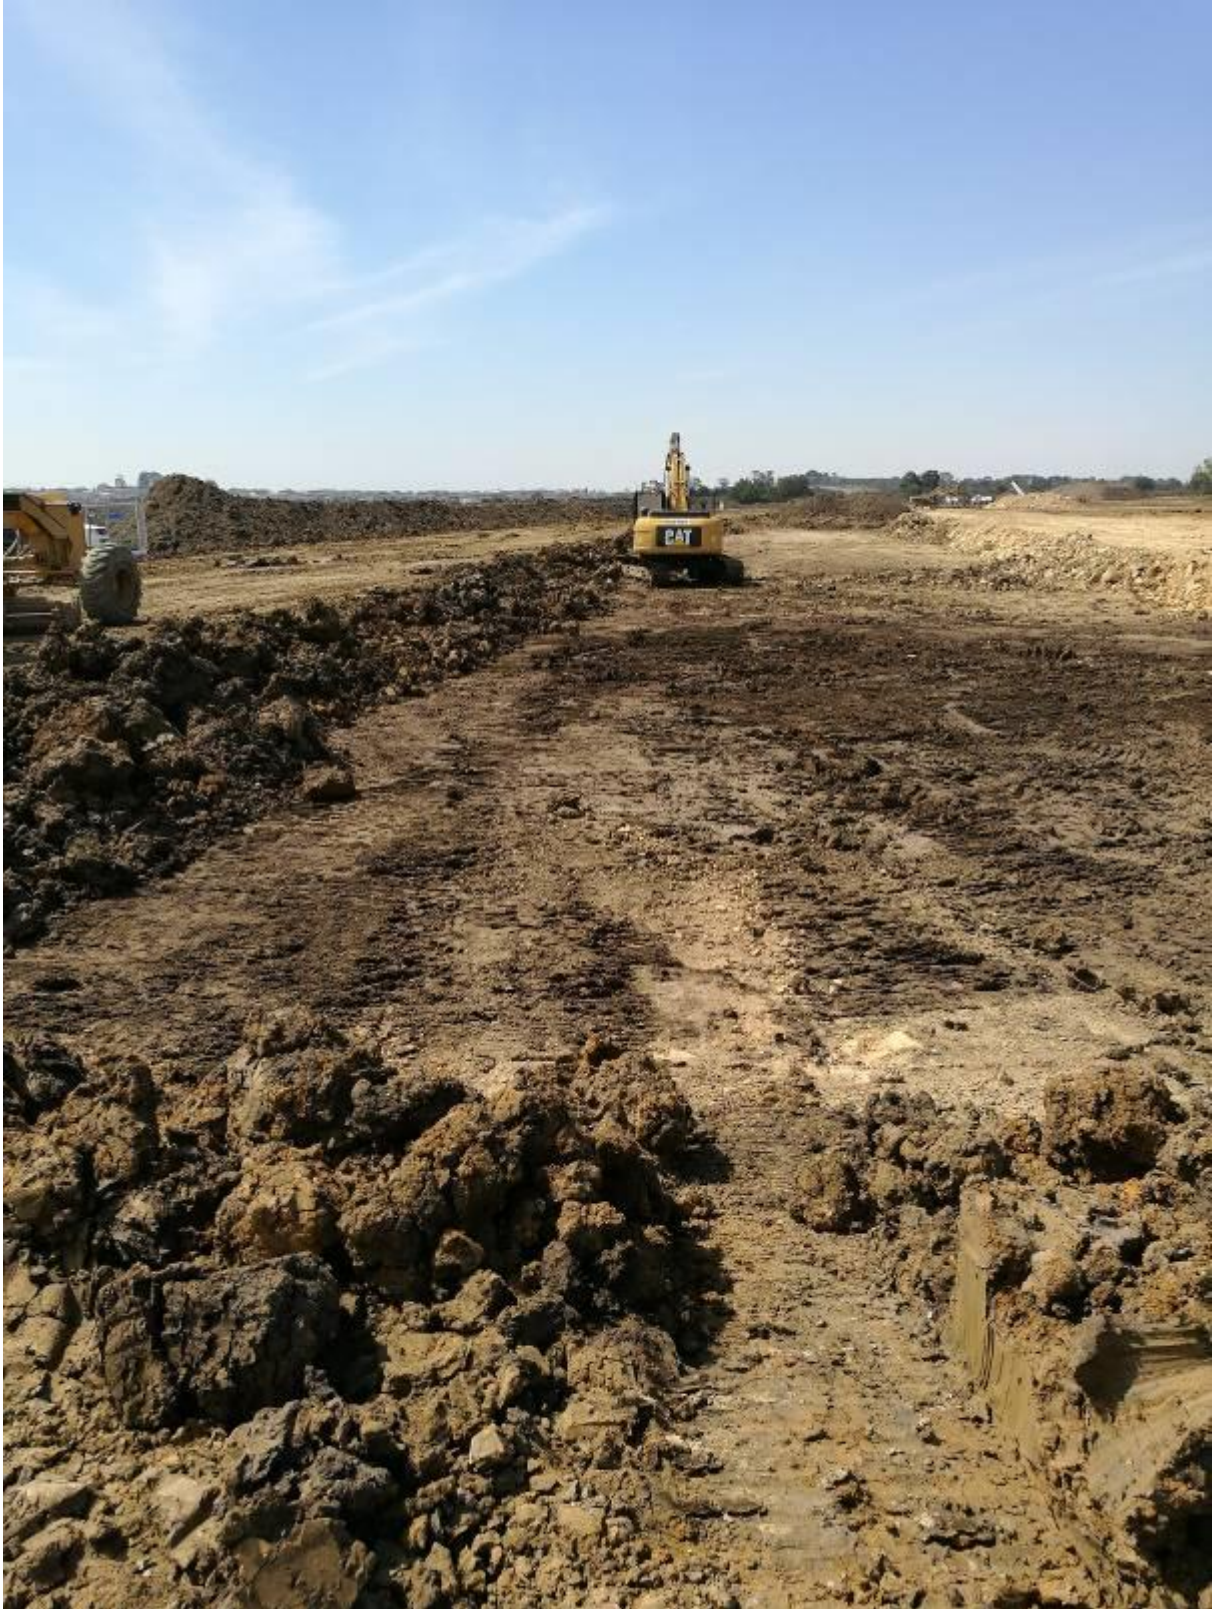
IMAGE FROM SITE
WATERSIDE ESTATE, CLYDE NORTH

A visual inspection of the area shown on the attached plan was undertaken on 10 March 2017. The area was stripped of all topsoil and organic matter to a firm subgrade. This was found to be adequate for filling to commence.

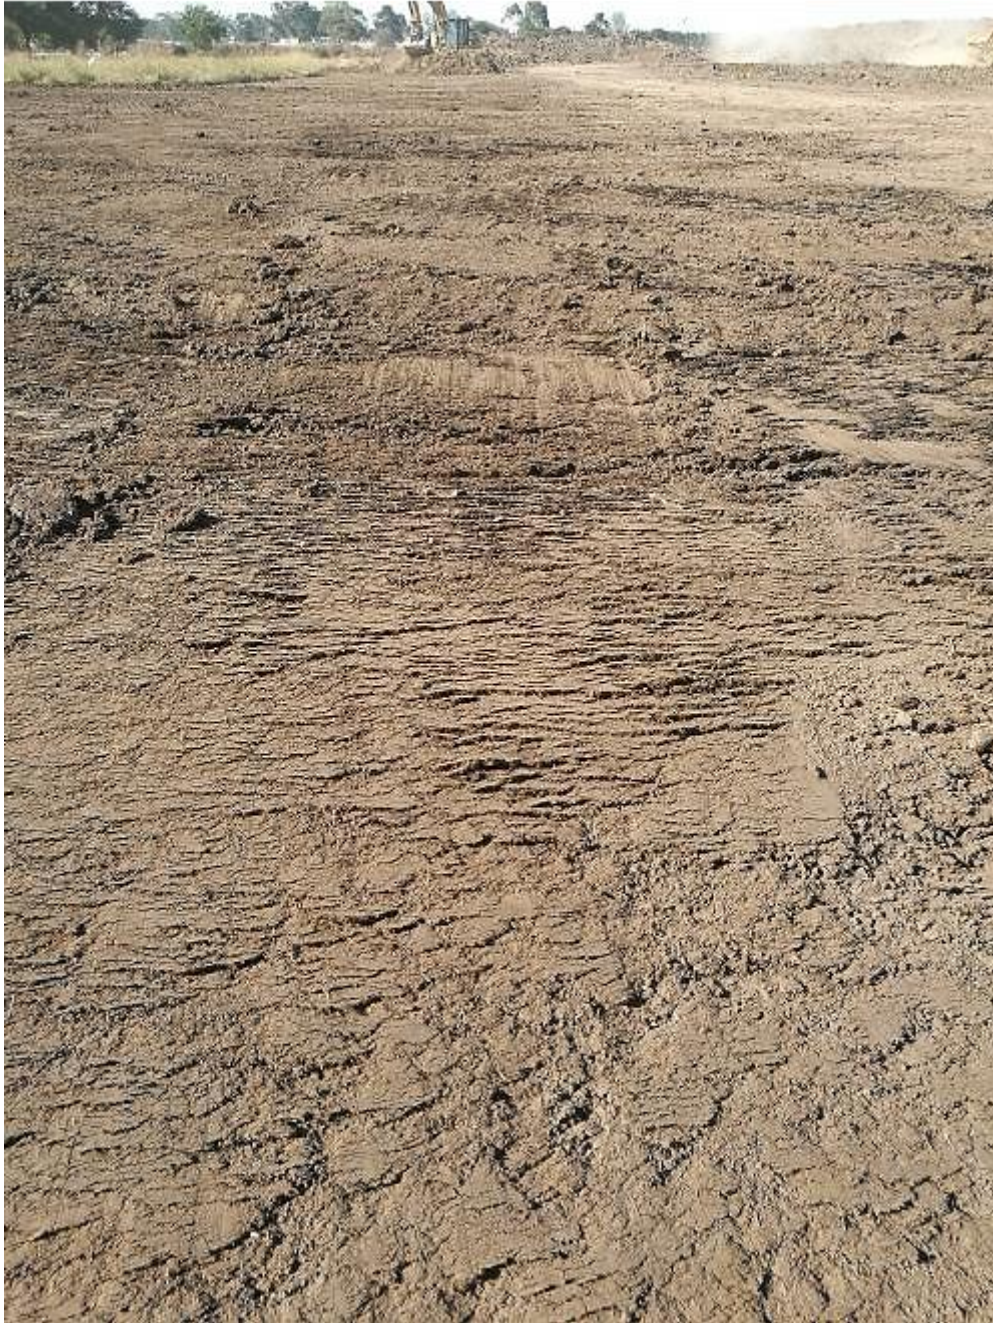
IMAGE FROM SITE

A visual inspection of the area shown on the attached plan was undertaken on 14 March 2017. The area was stripped of all topsoil and organic matter to a firm subgrade. This was found to be adequate for filling to commence.

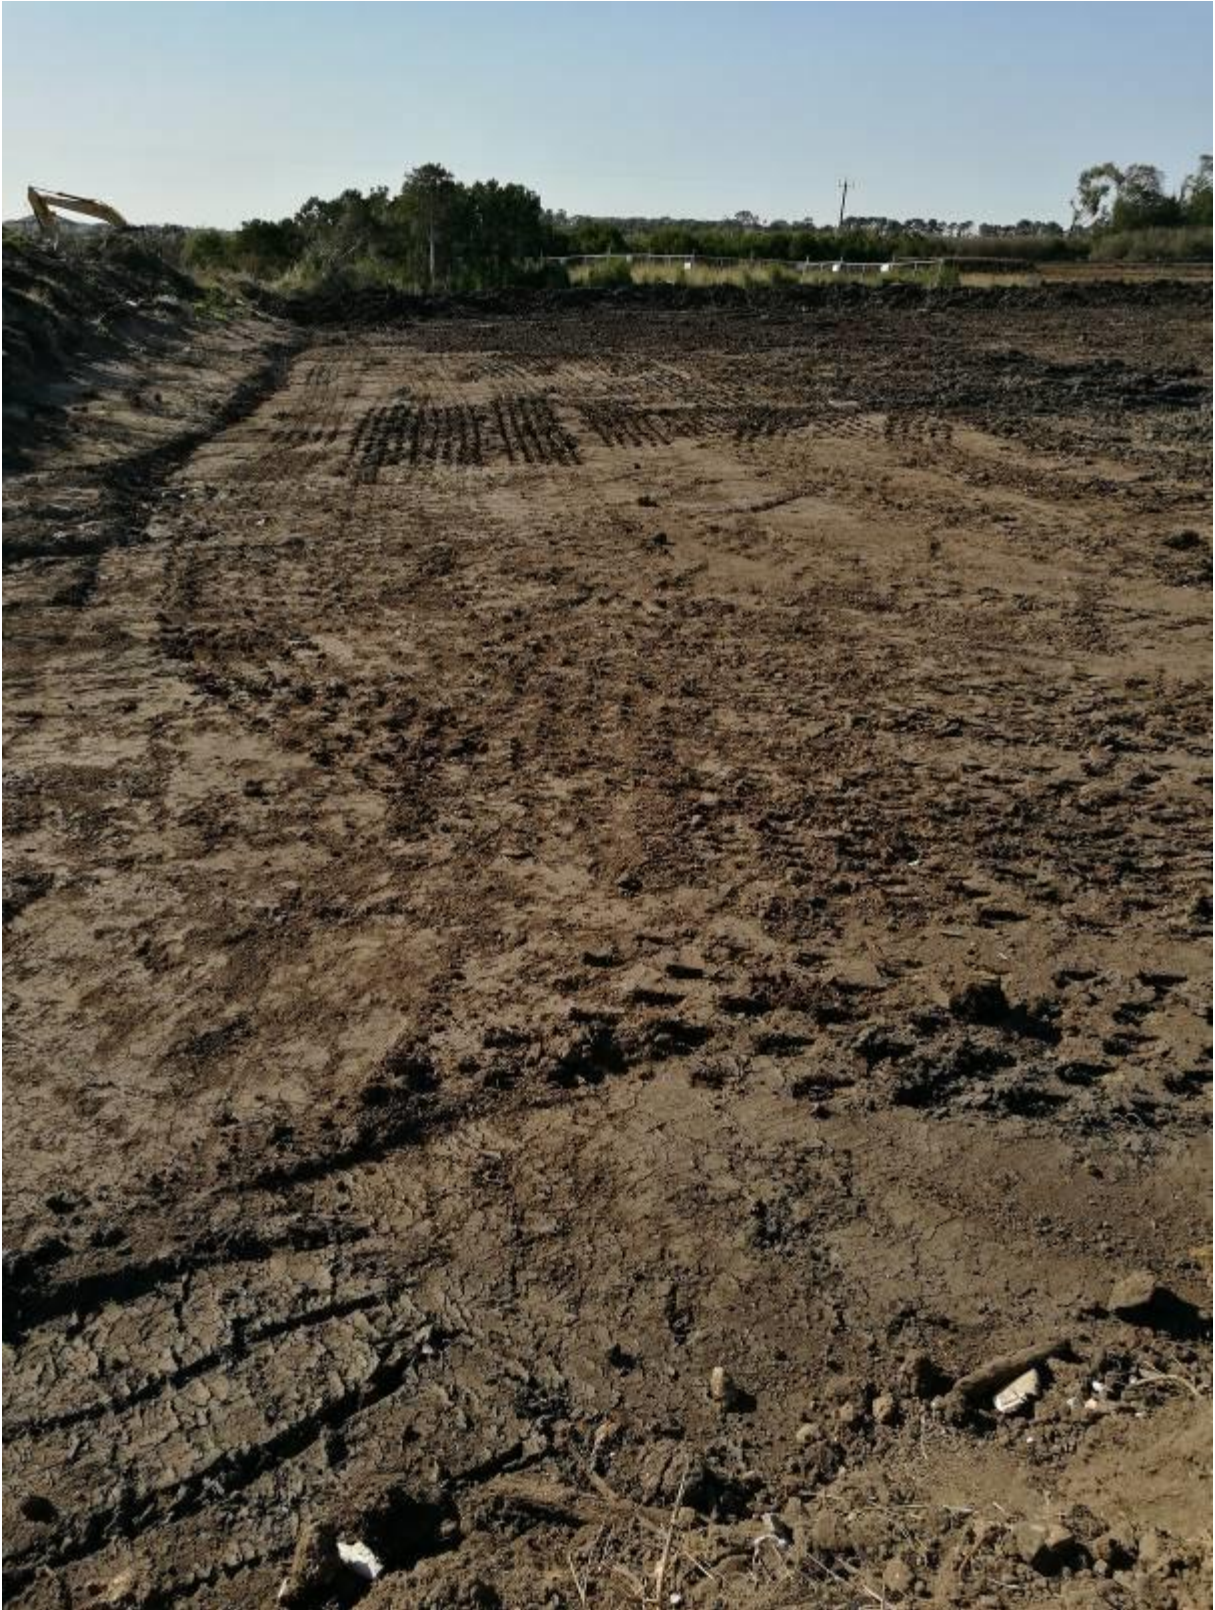
IMAGE FROM SITE
WATERSIDE ESTATE, CLYDE NORTH

A visual inspection of the area shown on the attached plan was undertaken on 3 April 2017. The area was stripped of all topsoil and organic matter to a firm subgrade. This was found to be adequate for filling to commence.
