**A REPORT ON THE LEVEL 1
INSPECTION AND TESTING AT
1100 POUND ROAD
WATERSIDE ESTATE
CLYDE NORTH**

Report No: 1170051-51

CITY OF CASEY
WATERSIDE ESTATE
MW WETLAND BULK EARTHWORKS
FILLING PLAN

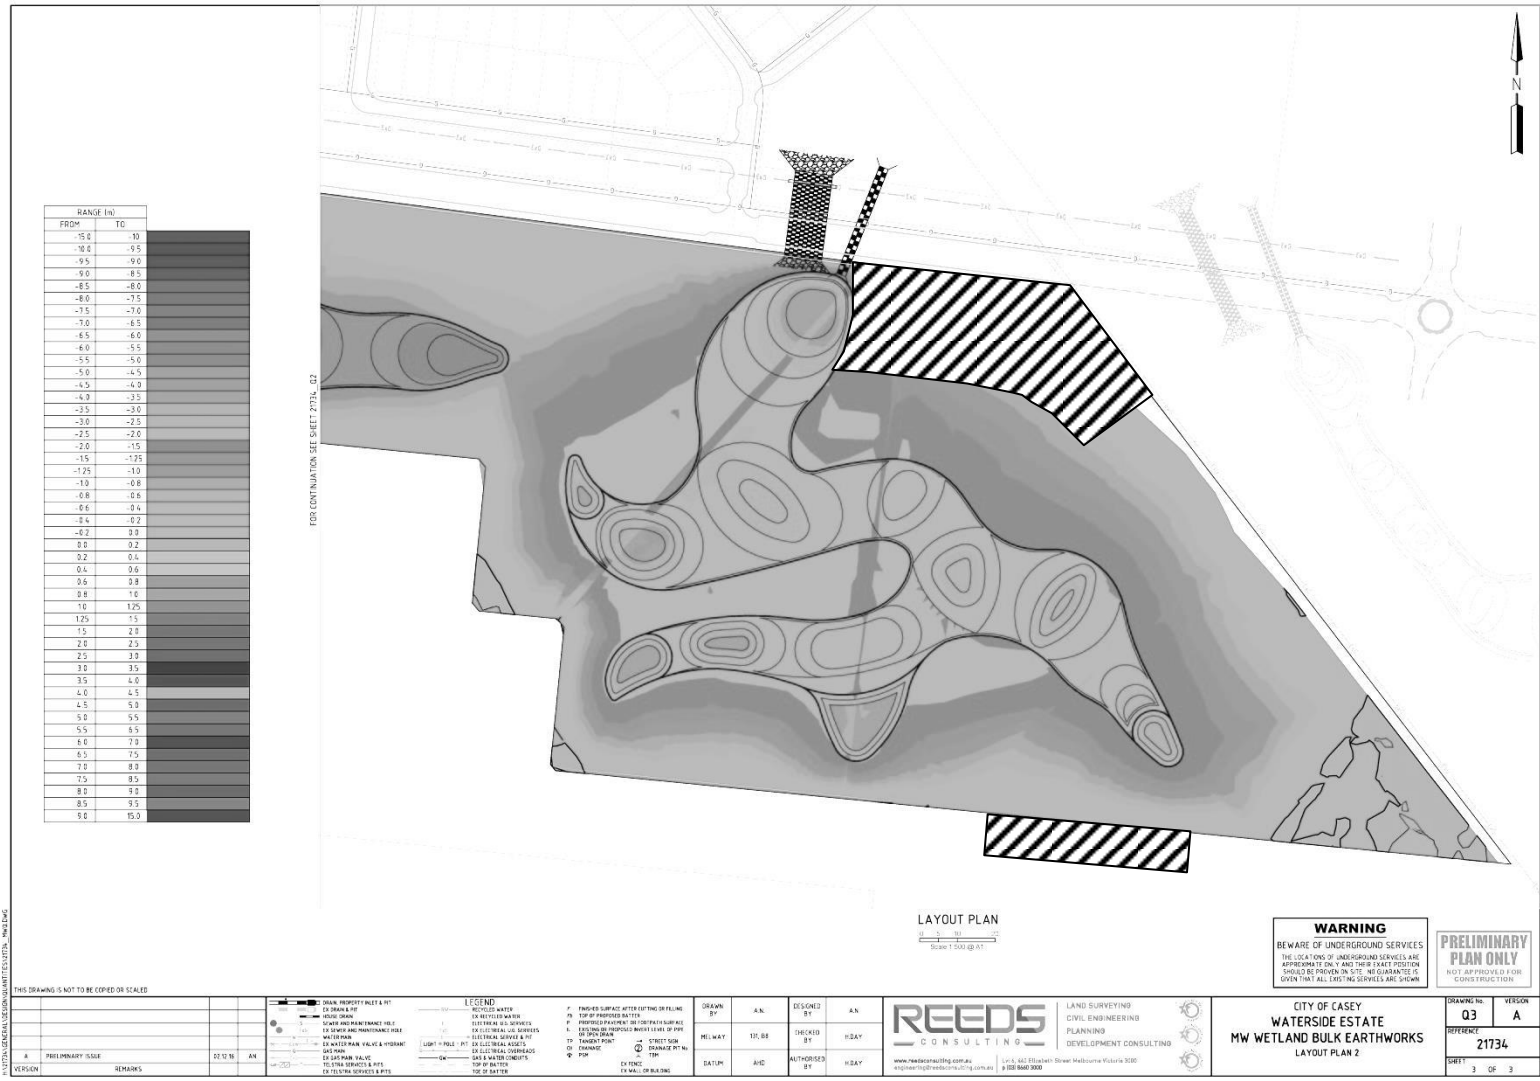
SITE INSPECTION PLAN: WATERSIDE ESTATE, CLYDE NORTH

A visual inspection of the area shown on the attached plan was undertaken on 3 April 2017. The area was stripped of all topsoil and organic matter to a firm subgrade. This was found to be adequate for filling to commence.

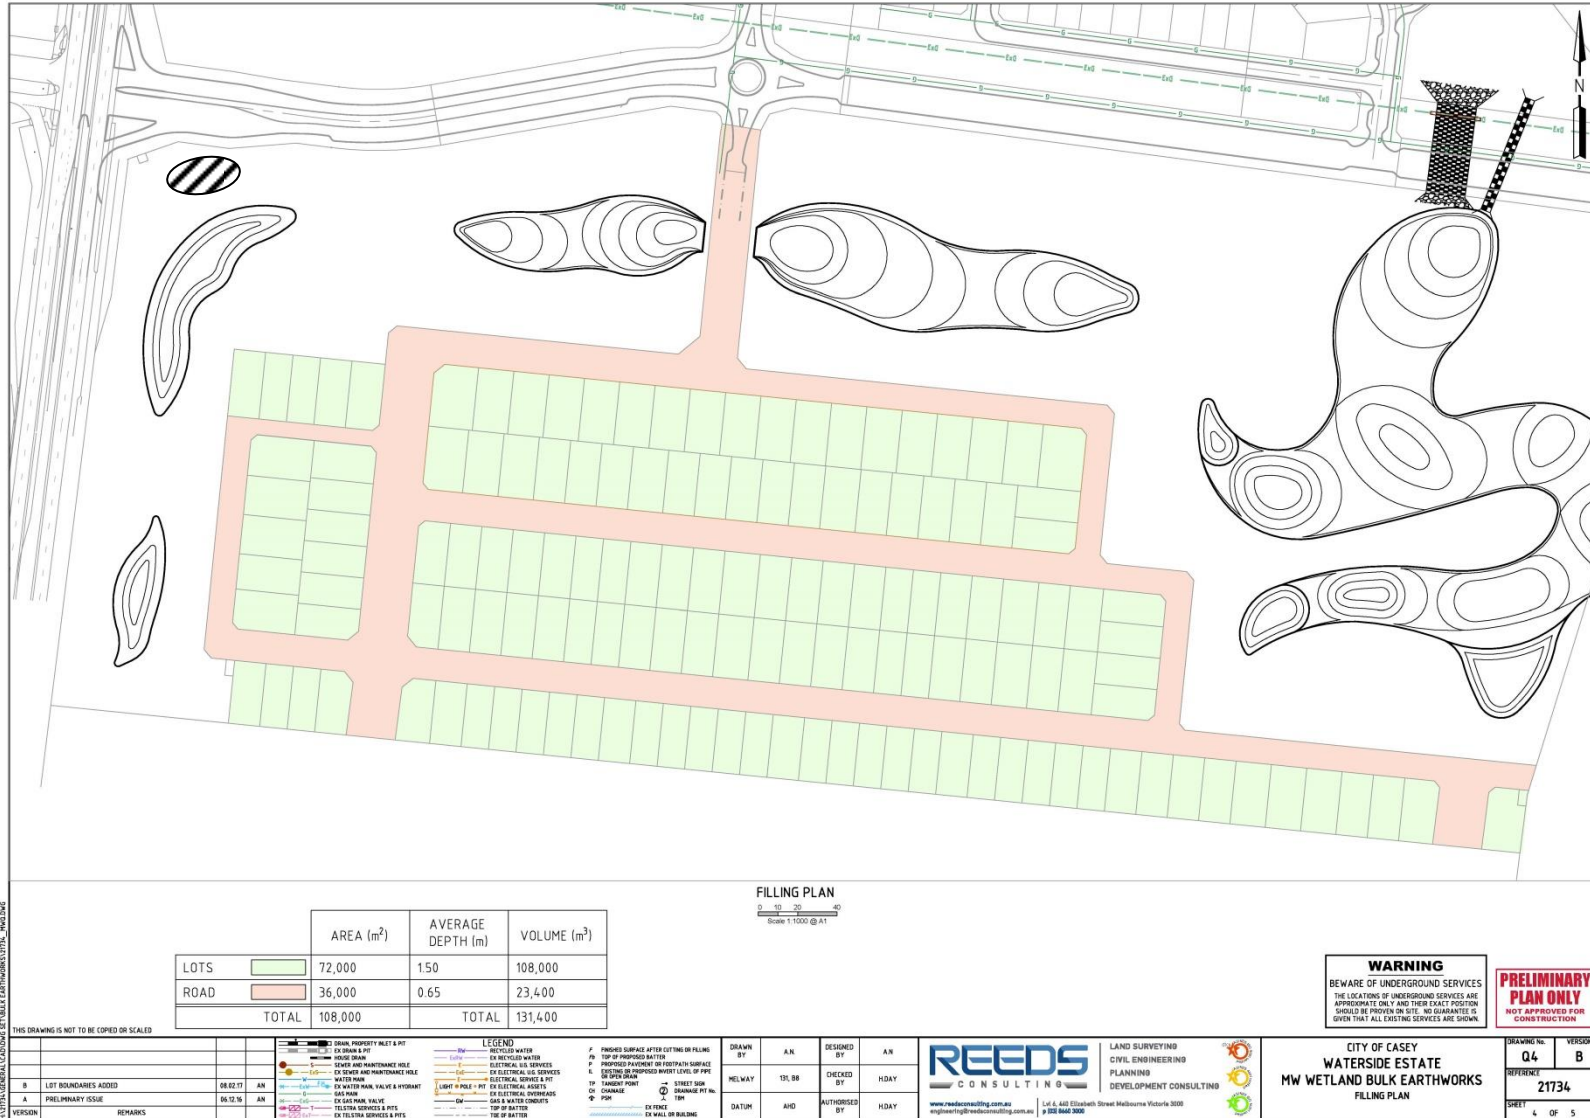
SITE INSPECTION PLAN: WATERSIDE ESTATE CLYDE NORTH

A visual inspection of the area shown on the attached plan was undertaken on 15 May 2017. The area was stripped of all topsoil and organic matter to a firm subgrade. This was found to be adequate for filling to commence.

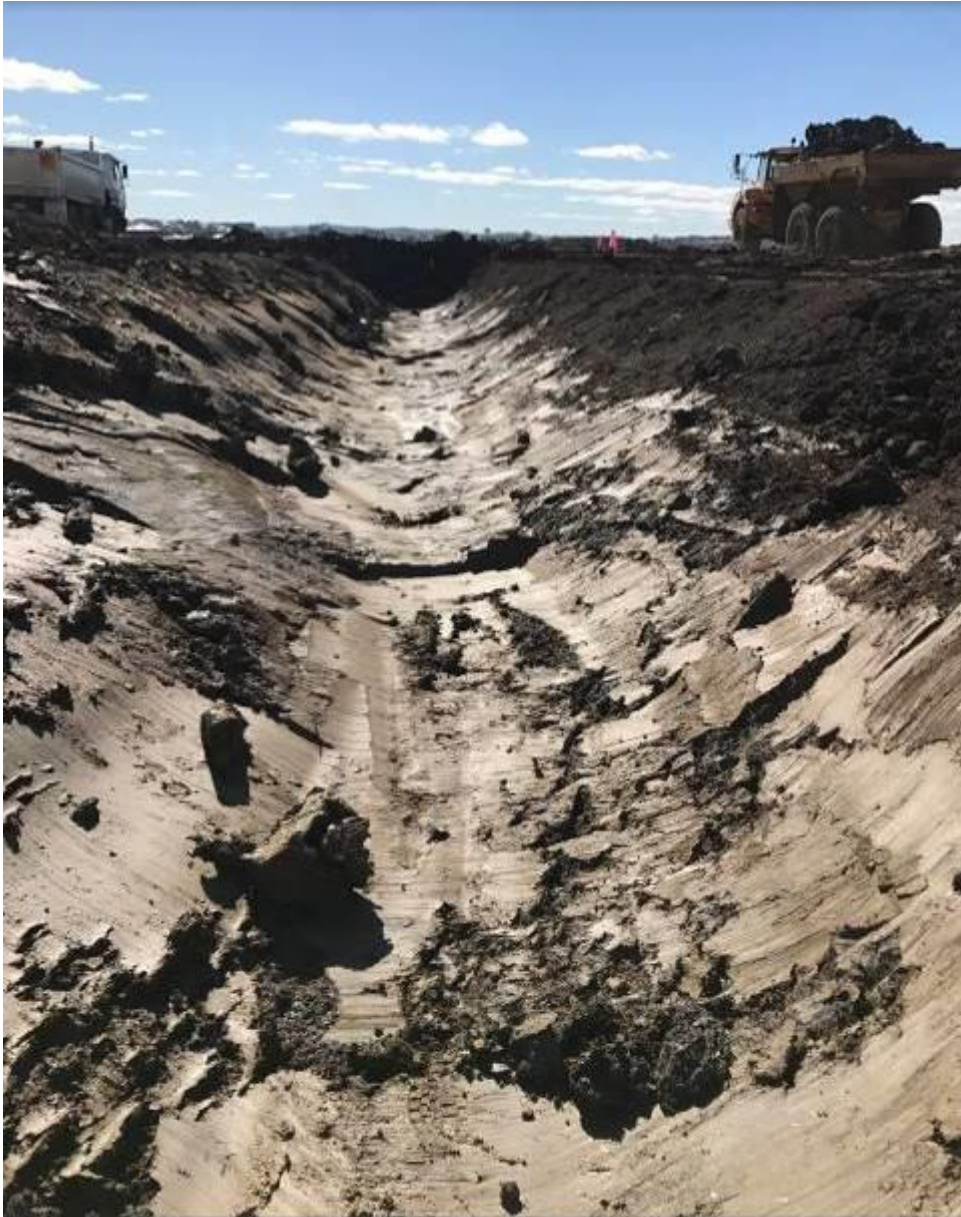
IMAGE FROM SITE
WATERSIDE ESTATE, CLYDE NORTH

A visual inspection of the area shown on the attached plan was undertaken on 28 August 2018. The area was stripped of all topsoil and organic matter to a firm subgrade. This was found to be adequate for filling to commence.

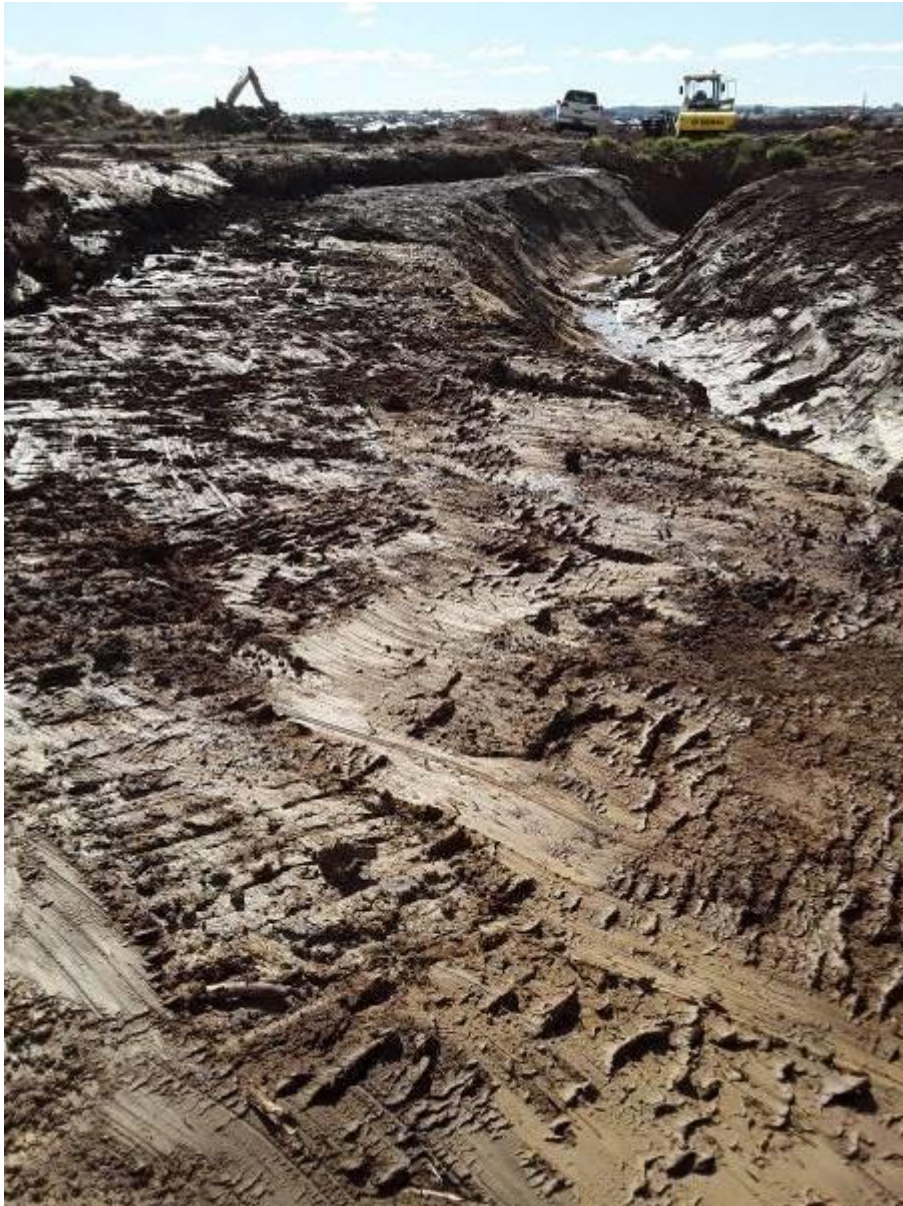
IMAGE FROM SITE
WATERSIDE ESTATE, CLYDE NORTH

A visual inspection of the area shown on the attached plan was undertaken on 3 September 2018. The area was stripped of all topsoil and organic matter to a firm subgrade. This was found to be adequate for filling to commence.

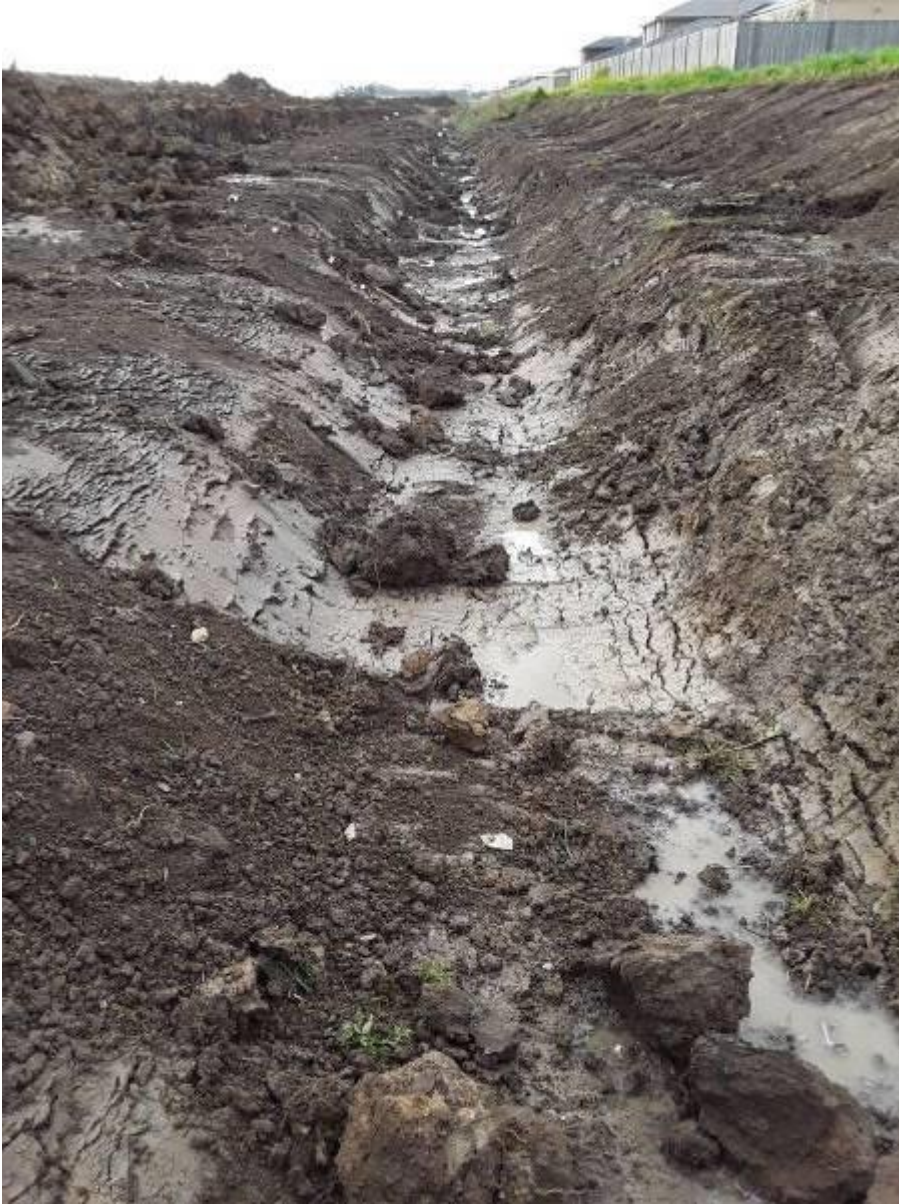
IMAGE FROM SITE
WATERSIDE ESTATE, CLYDE NORTH

A visual inspection of the area shown on the attached plan was undertaken on 7 September 2018. The area was stripped of all topsoil and organic matter to a firm subgrade. This was found to be adequate for filling to commence.

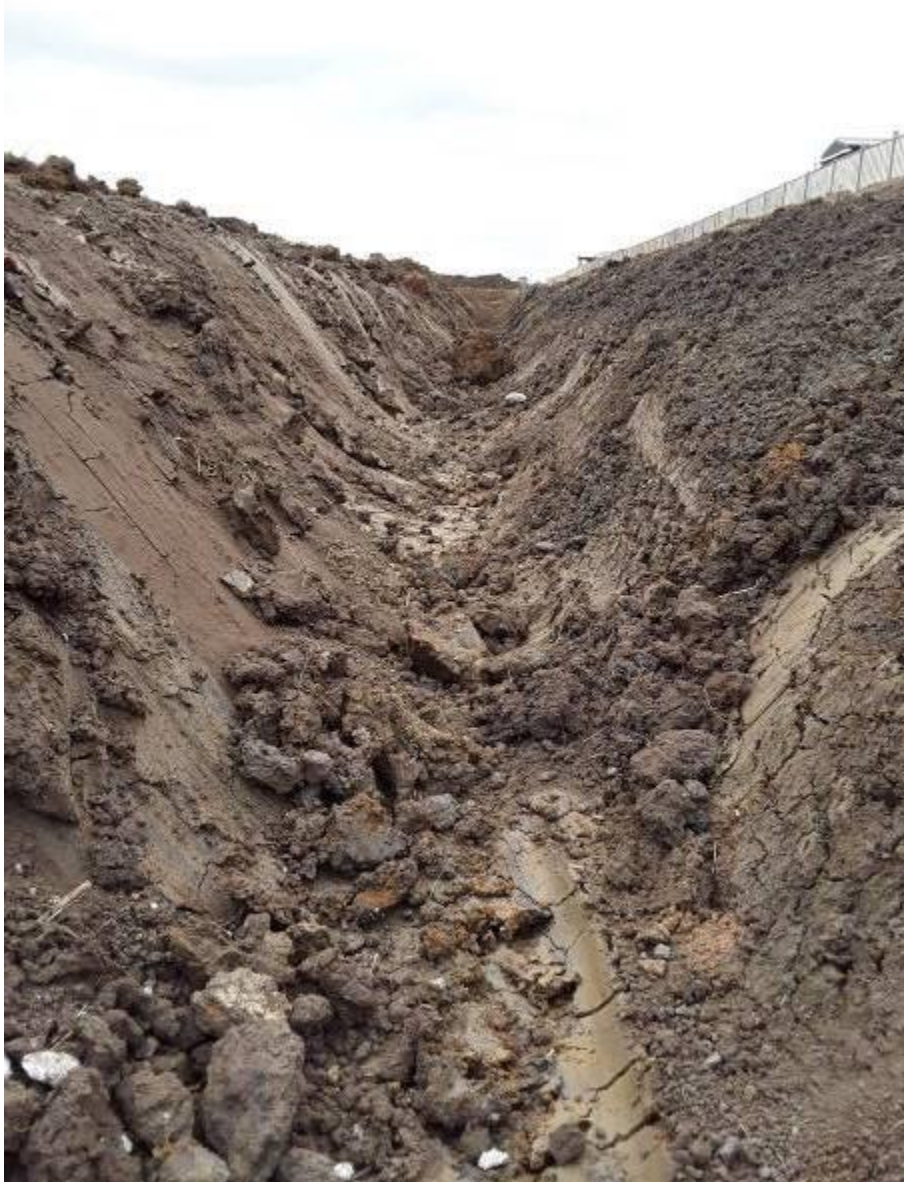
IMAGE FROM SITE
WATERSIDE ESTATE, CLYDE NORTH

A visual inspection of the area shown on the attached plan was undertaken on 10 September 2018. The area was stripped of all topsoil and organic matter to a firm subgrade. This was found to be adequate for filling to commence.
